Historical Resources Technical Report

HISTORICAL RESOURCES TECHNICAL REPORT FOR NORTH RIVER FARMS

5401 North River Road and 297 Wilshire Road,
Oceanside, California

JUNE 2018

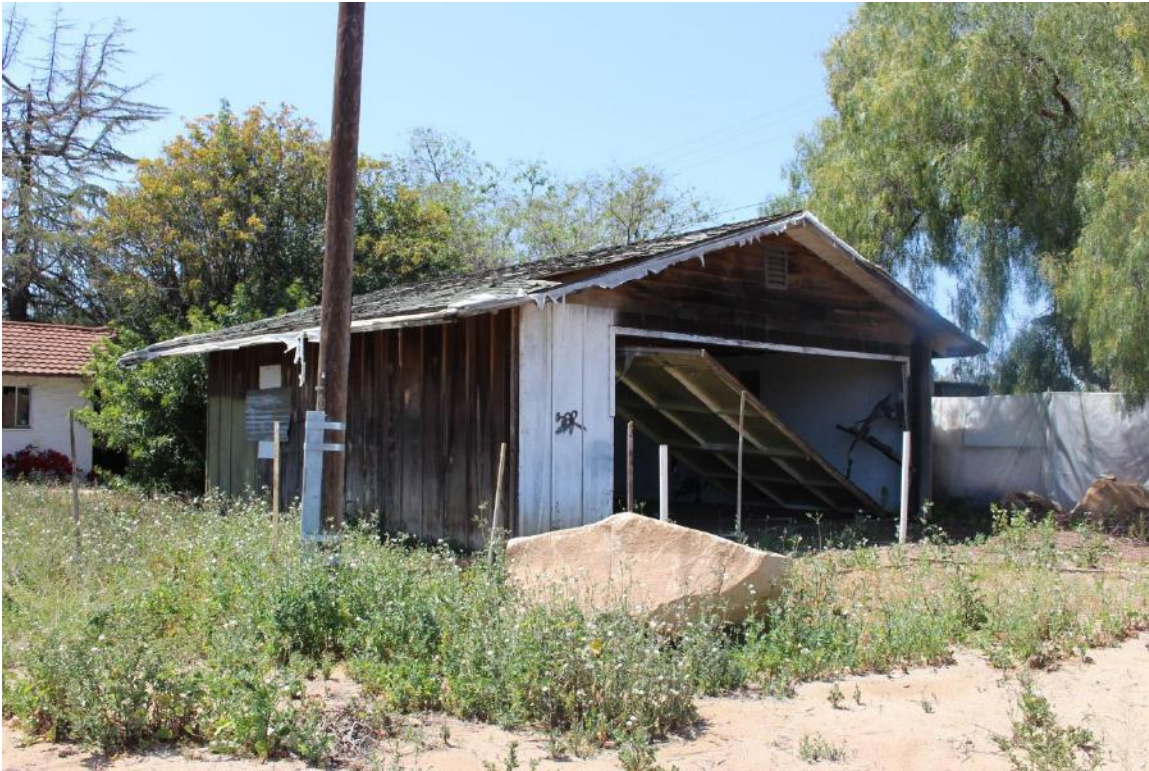
Figure 5 Garage building, view looking northwest. (IMG_8496)

Building 1 is a front-gabled, two-car garage with board-and-batten exterior walls, and horizontal boards on the gable ends. The building rest on a concrete foundation. The roof is sheathed in plywood and covered in asphalt shingles. A detached up-and-over style wood garage door leans against the southern portion of the garage door opening on the east (main) elevation. Other fenestration includes two single windows, one each piercing the western portion of the north and south elevations, and a single doorway on the west elevation. The interior of the garage is finished, with a row of cabinets along the rear (west) wall.

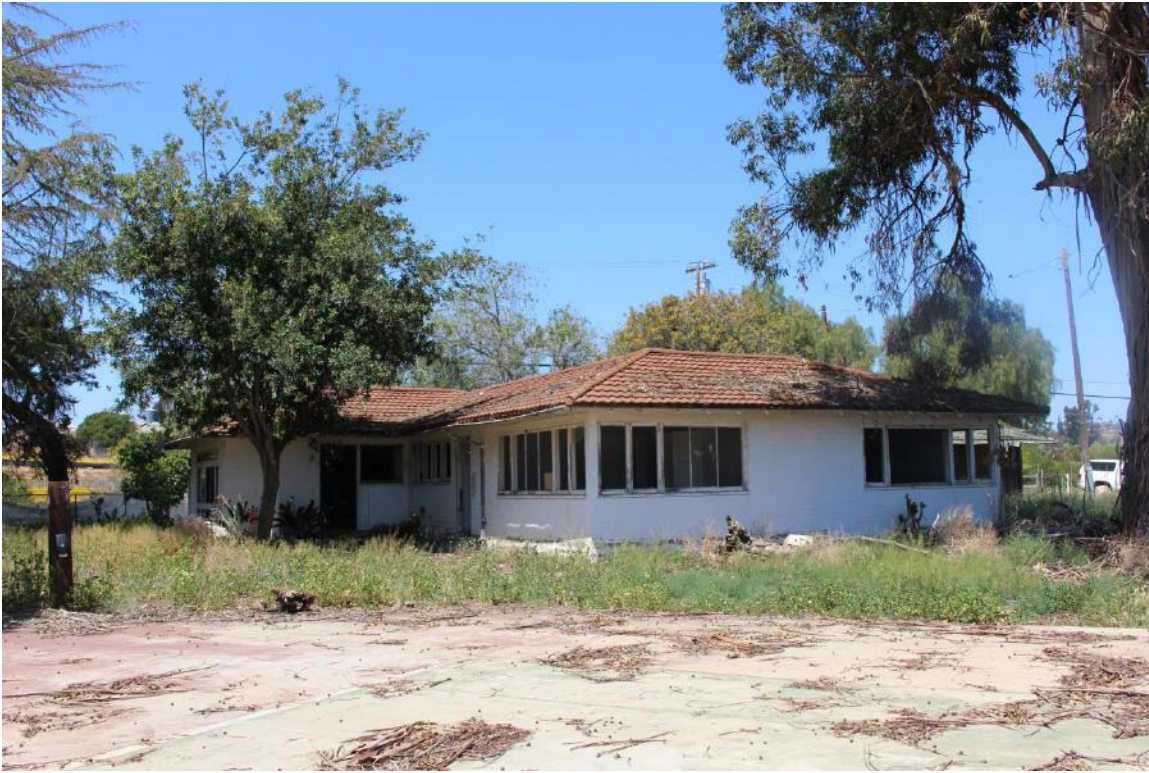
Figure 6 **Z-shaped brick house, view looking northeast. (IMG_8517)**

Building 2 is a single-story, brick single-family residence with a hipped roof clad in tile similar in shape to the Decra Classic lightweight steel tile. The building has a Z-shape in plan, and rests on a concrete foundation. Multiple single three-panel wood doors provide access on all but the north elevation. A French door provides access on the northern portion of the east elevation. Windows occur in ribbons that typically meet at the house corners. They are wood-framed and include single-lite casement windows, fixed single-lite windows, and fixed picture windows. The windows on the north elevation and north section of the west elevation are bordered on top and bottom with a string of narrow windows. A chimney juts upwards on the north elevation.

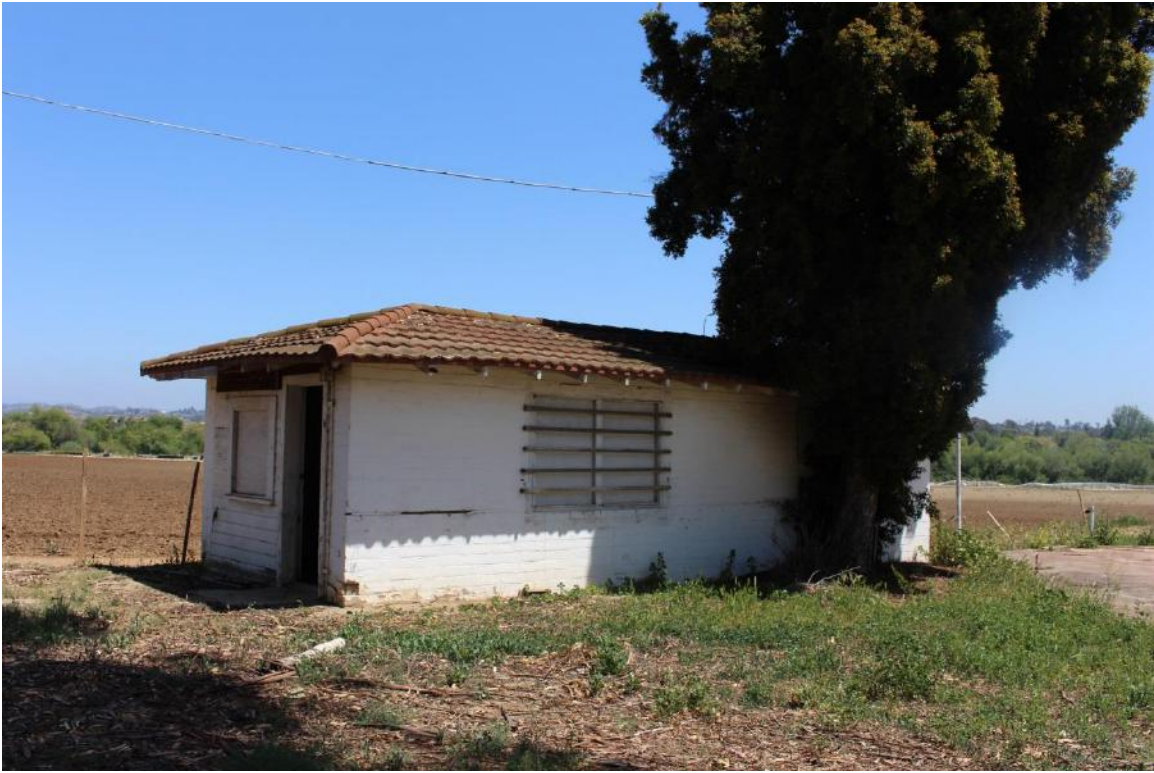
Figure 7 **Small two-room residence, view looking southeast. (IMG_8518)**

Building 3 is a small, single-story residence with a hipped roof clad in tile similar in shape to the Decra Classic lightweight steel tile. Rectangular in plan, the building has three brick walls and one stud wall clad in wood clapboards; the building rests on a concrete foundation. A single three-panel door provides access to the main room on the north (main) elevation. Fenestration is limited, consisting of casement windows and a square opening on the north elevation that may have been a service window. An addition to the rear of the building houses a combined kitchenette and bathroom. The wooden wall with entrance door and the addition of bathing and cooking facilities indicate this building was adapted to serve as a residence.

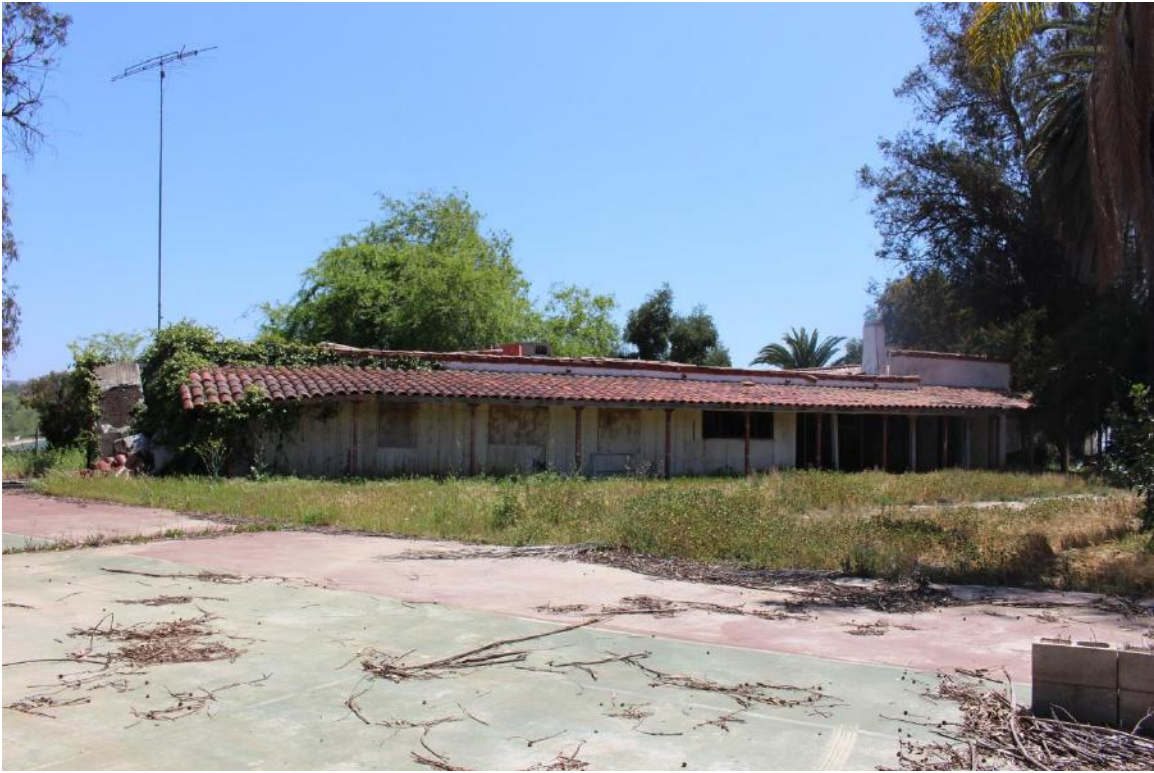
Figure 8 **Large residence, view looking south-southwest. (IMG_8563)**

Building 4 is a single-story, single-family Spanish Colonial Revival style residence with a complex roof form clad in tapered half-barrel clay Mission tiles and Spanish S-shaped clay tiles. The building has a C-shape in plan, is clad in stucco and board-and-batten wood planks, and appears to rest on concrete foundations. Multiple single wood doors and sliding glass doors provide access. A Spanish style wood door with iron grille work provides access to the great room from the courtyard. Windows are numerous and include single-lite casement windows, fixed single-lite windows, and unidentifiable boarded-over windows. Two chimneys jut upward, ones on the west elevation and the other internally. A deep, covered patio extends full-length along the north elevation, while a second deep, covered patio wrap around the interior of the courtyard. The great room on the western side of the building retains several elements of Spanish Colonial Revival, including exposed King trusses with decorative corbels, exposed roof beams, and arched wall openings. Later alterations include 1950s-era stone work cladding both fireplaces and forming a low wall along the southern edge of the courtyard; late 20th Century kitchen remodel, sliding glass doors, air ducts, and wiring conduit; several stages of additions to the north elevation including the board-and-batten expansion and multiple generations of extensions to the patio roof; and an added wing on the southeastern

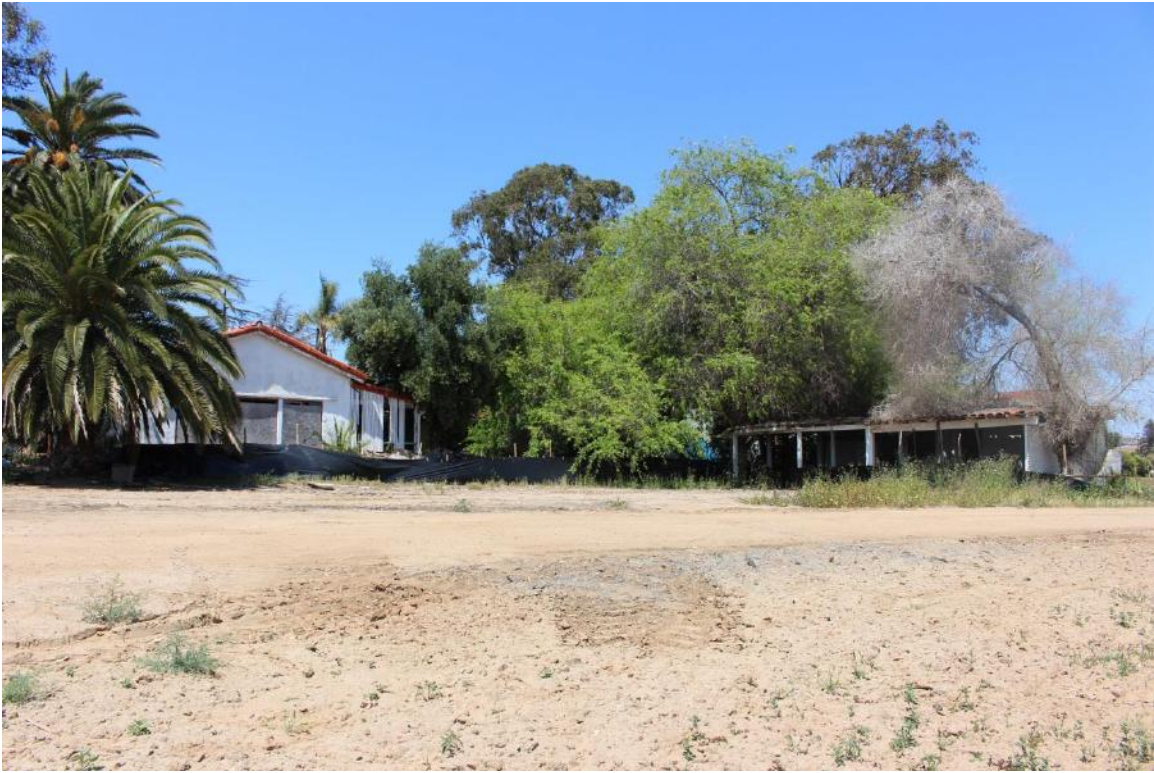
Figure 9 Large residence, view looking north-northwest. Vegetation obscures the central courtyard area. (IMG_8544)

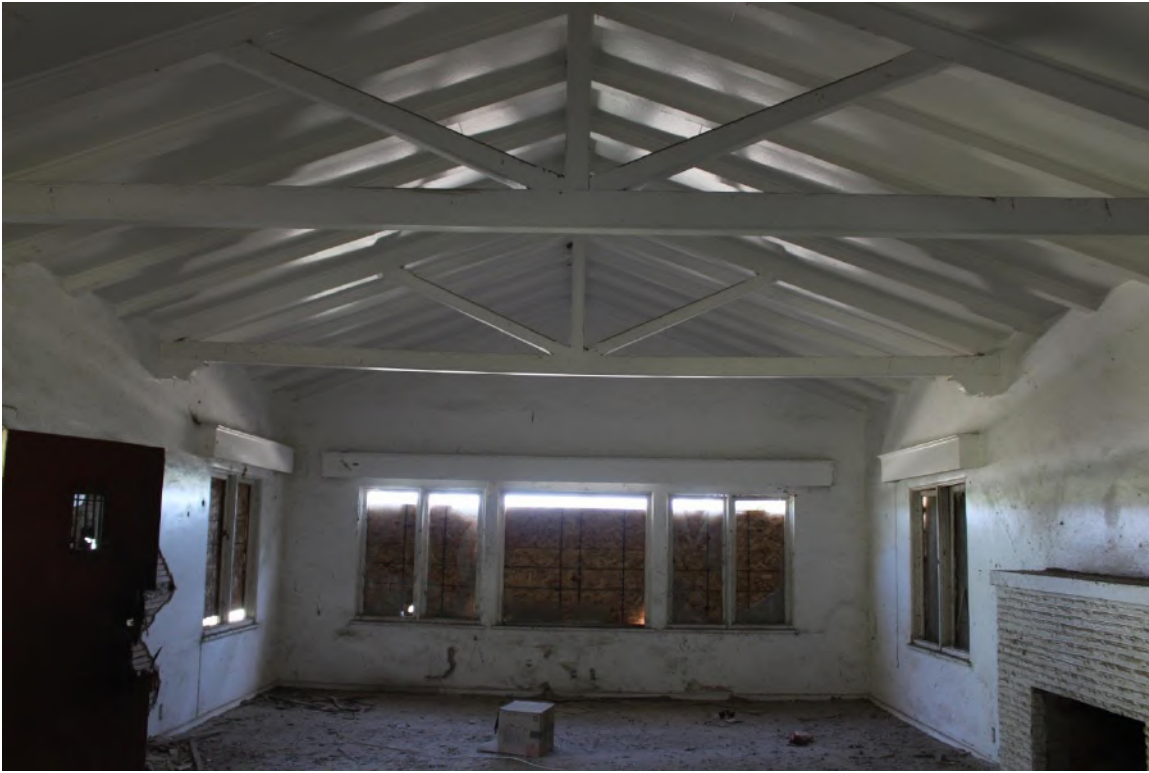
Figure 10 Interior of Great Room, western portion of the building, view looking south. Notice the Spanish Colonial Revival style influences in the iron grille door insert, chamfered king post trusses supported by ogee corbels, and exposed beams. (IMG_8588)

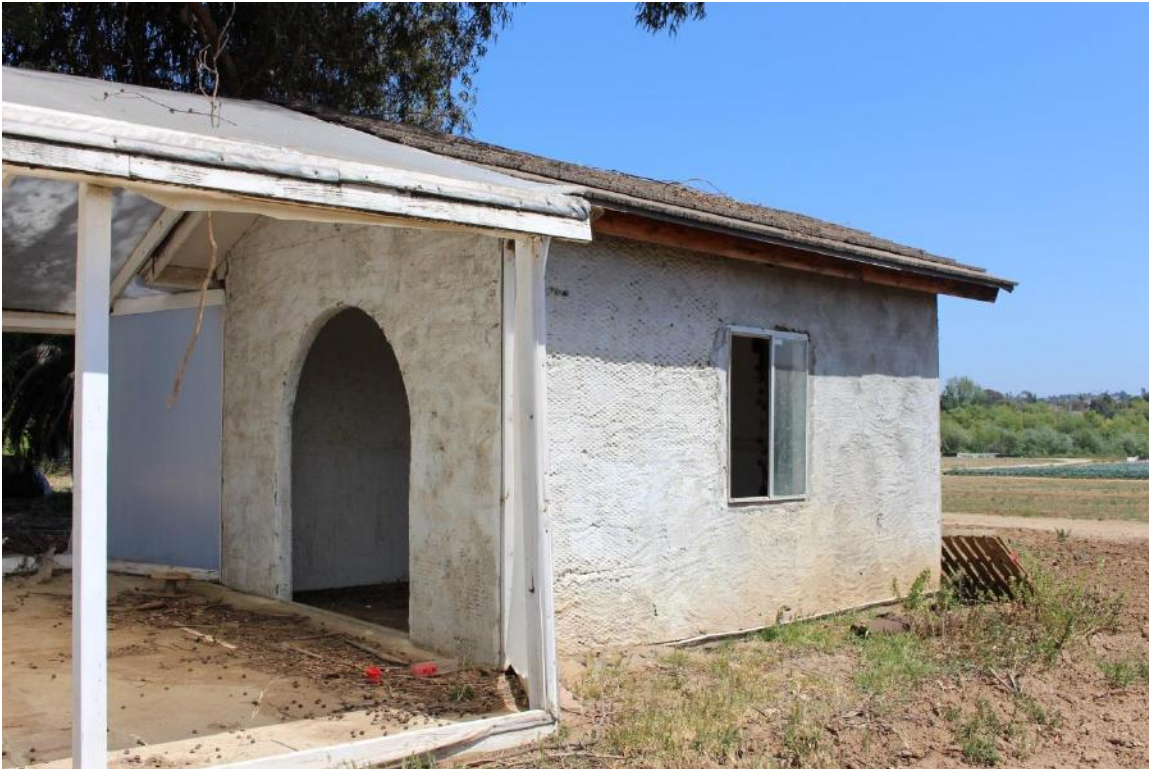
Figure 11 Small miscellaneous building, view looking southeast. (IMG_8646)

Building 5 is a single-story, one-room building with a front-gable roof clad in asphalt composition shingles. The building has an earthen floor and may or may not have a perimeter foundation. The walls are clad with unfinished stucco, leaving portions of the wire mesh exposed. An arched opening is on the north (main) elevation, and the east and west elevations each have a single aluminum-framed sliding window. A front-gabled shade structure attached to a concrete slab, with translucent polythene sheeting covering the rafters, is attached to the north elevation.

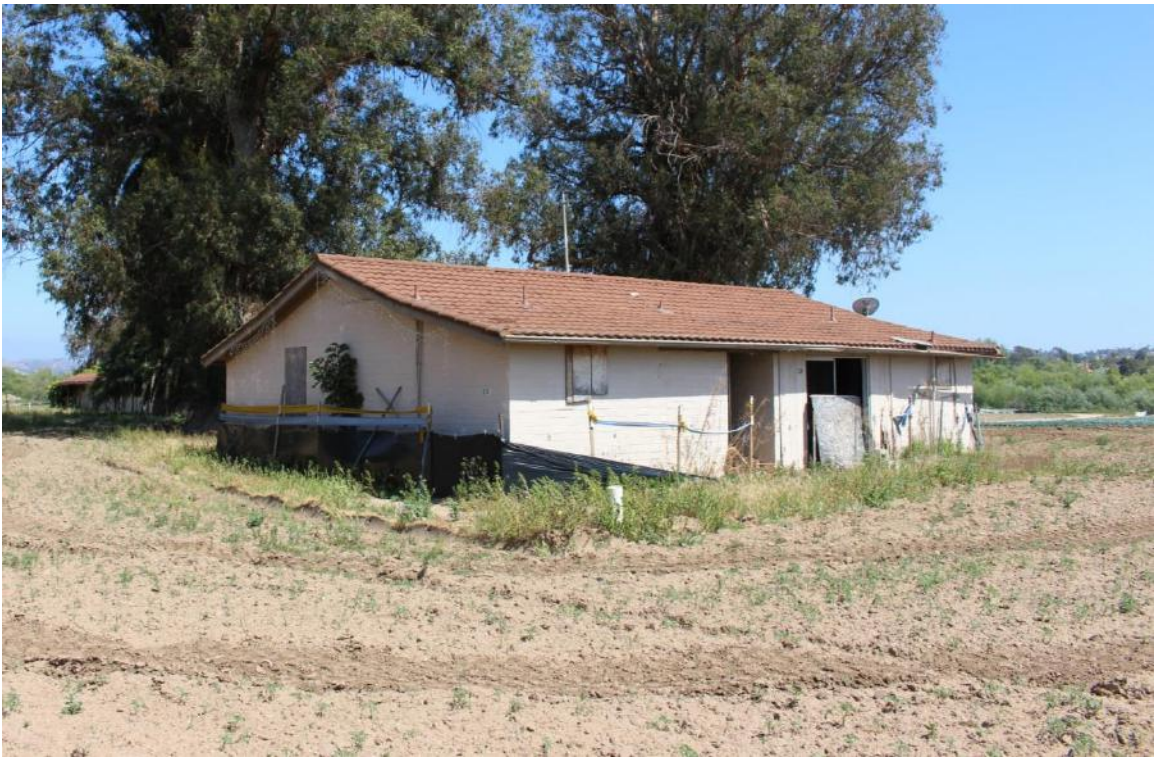
Figure 12 **Residence, view looking southeast. (IMG_8651)**

Building 6 is a side-gabled residence with brick walls and a roof clad in tile similar in shape to the Decra Classic lightweight steel tile. An integral porch is centered on the east (main) elevation. Fenestration is regular and mostly symmetrical, with a limited number of windows on each elevation and single doors granting access from the east elevation. The west elevation has a central portion clad in vertical boards that houses a sliding glass door. Adjacent to this section is a full-height opening bordered on the northern side by an infilled brick wall. The house appears to originally have been a duplex with enclosed patios on the east and west elevation, but at some later date it was changed into a single-family residence.

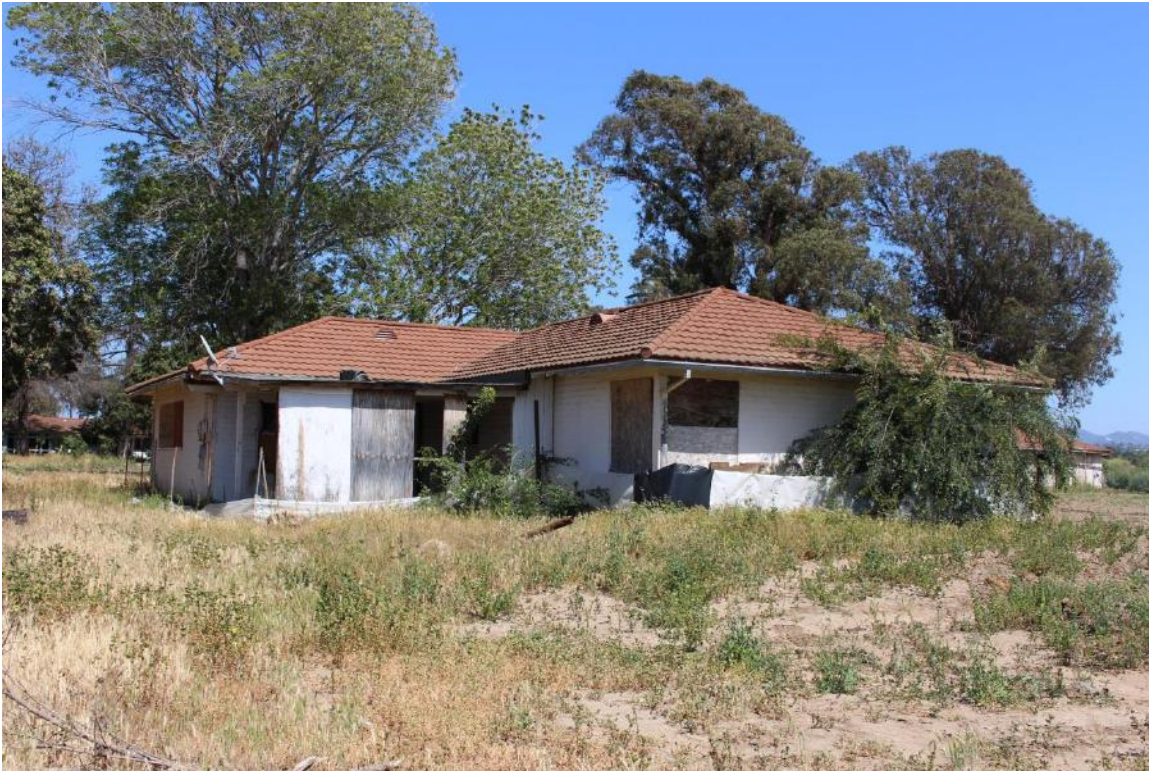
Figure 13 **Single-family residence, view looking southeast. (IMG_8665)**

Building 7 is a single-story, brick single-family residence with a hipped roof clad in tile similar in shape to the Decra Classic lightweight steel tile. The building has a Z-shape in plan, and rests on a concrete foundation. Multiple single doors provide access on the east and west elevations. Windows are located at the house corners, with some piercing the elevations at random locations. They were wood-framed but are either missing or boarded over. A large chimney juts upwards on the south elevation. A covered patio was added at some point to the west elevation, over the main entrance.

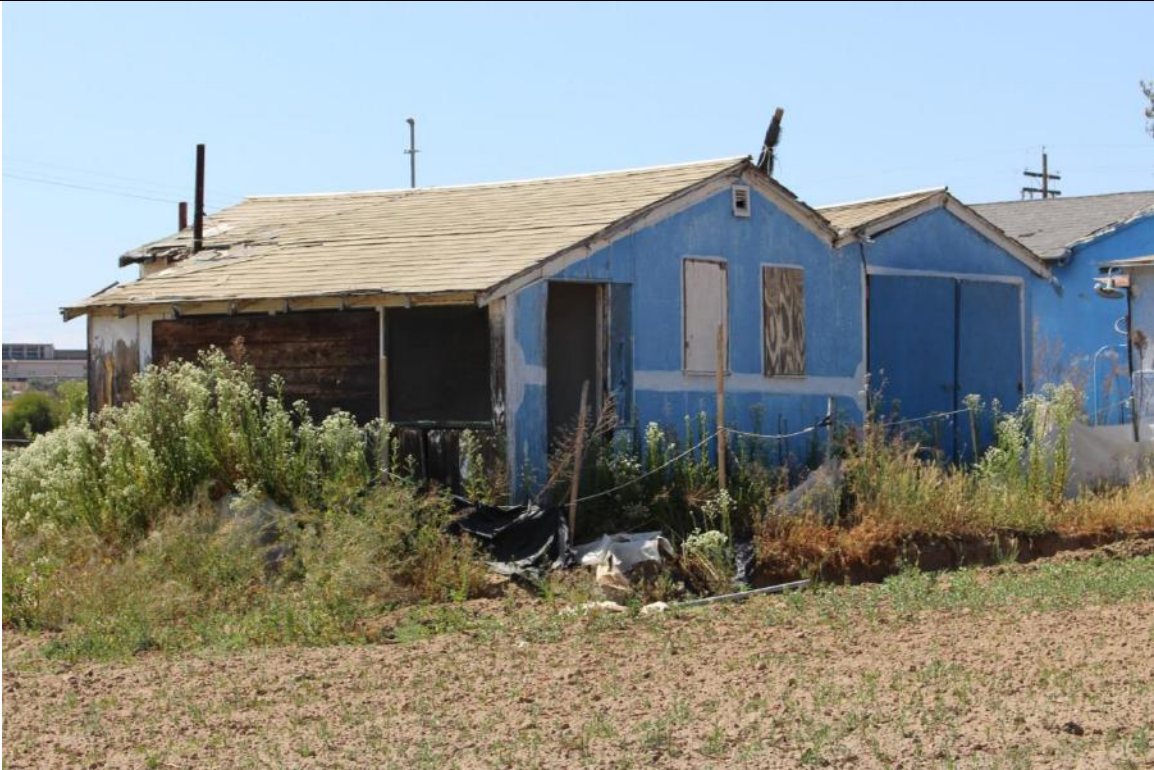
Figure 14 **Residence, view looking northwest. (IMG_8695)**

Building 8 is a double front-gable residence clad in a variety of materials, including stucco, board-and-batten, and vertical wood planks, with asphalt shingles cladding the roof. The northern front-gabled section serves as a single-car garage with carriage-style wood garage doors, while the southern front-gabled section provides living space. A shed-roofed addition is attached to the southern elevation, and provides access to the living quarters from the east elevation. The windows are boarded over, hampering identification of window types.

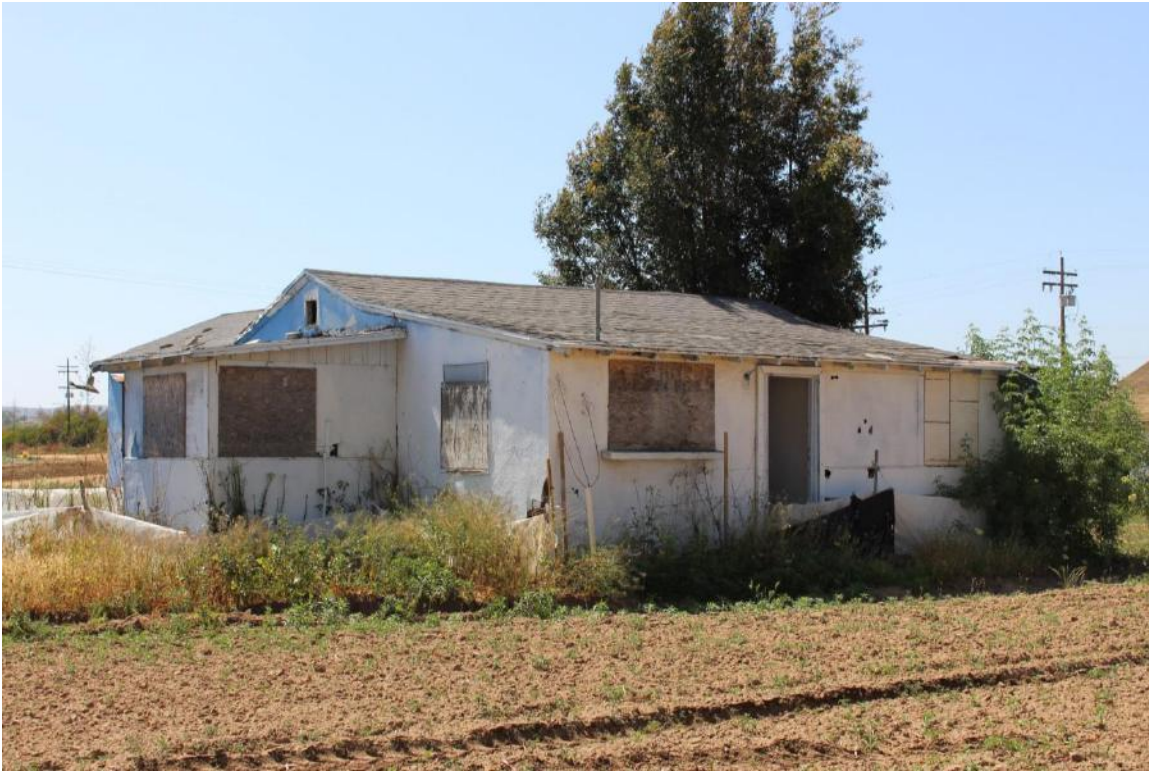
Figure 15 **Residence, view looking northwest. (IMG_8702)**

Building 9 is a front-gabled residence, with an enclosed shed-roof addition to the east (main) elevation and two front-gabled additions to the west elevation. A smaller shed-roofed addition juts from the south elevation. The majority of the building is clad in stucco, except for the small shed-roofed addition that is clad in wood. The roof is clad with asphalt shingles. Fenestration is irregular; the openings are boarded over, hampering identification of window types.

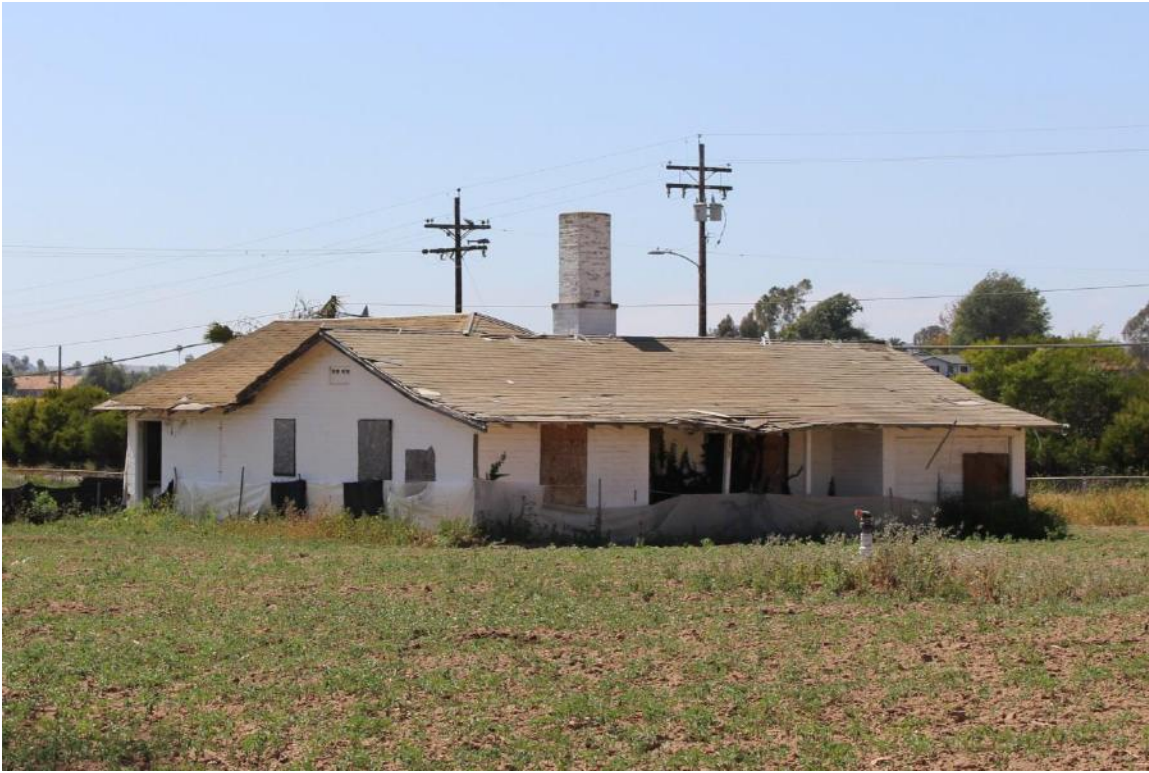
Figure 16 **Residence, view looking northwest. (IMG_8709)**

Building 10 is a one-story, brick, side-gabled residence with a large front-gabled addition on the west elevation. The roof is clad in asphalt shingles, and a large square chimney juts upward from the west elevation. The east (main) elevation has an integral patio in the center, that is flanked to the north by a narrow double-car garage. Fenestration is irregular; the windows are boarded over, hampering identification of window types. Several single doors provide access on the east (main), south, and west elevations. A small integral patio is sited on the west elevation, adjacent to the large addition, and shelters three single doors.

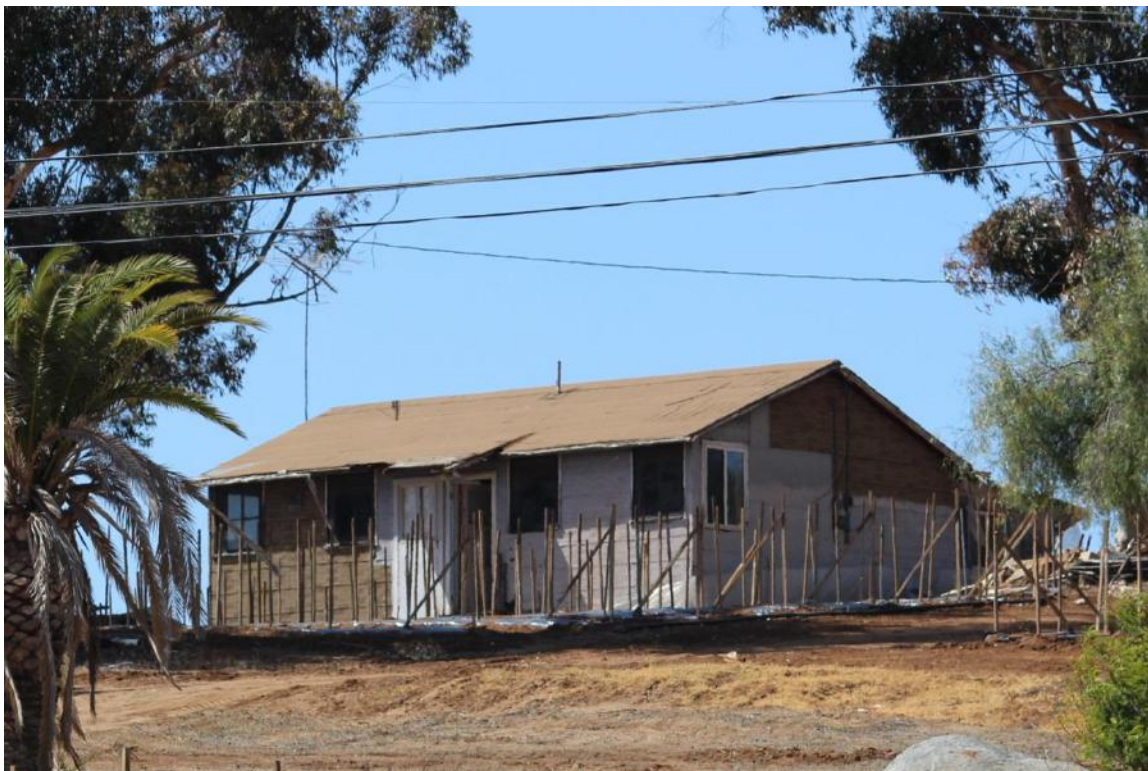
Figure 17 Residence, view looking northwest. (IMG_8740)

Building 11 is a single-story, front-gabled residence, clad in brick-patterned paper with a roof clad in rolled roofing material. The building is rectangular in plan and the foundation is post-and-beam. Two symmetrical flat-roofed additions just from the north elevation. Two single doors provide access from the south (main) elevation. Fenestration is regular, with both original and modern replacement slider windows. The symmetrical layout and two entrance doors imply this building is a duplex.

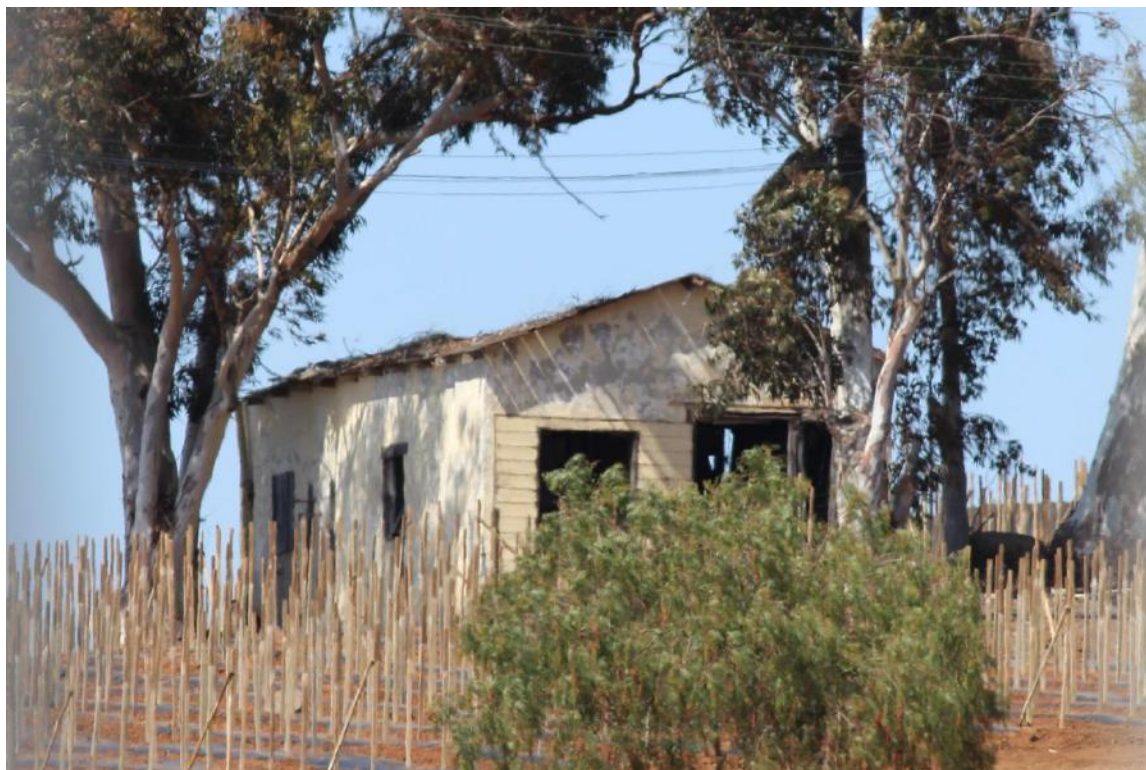
Figure 18 **Residence, view looking north-northeast. (IMG_8746)**

Building 12 appears to be a residence, but currently may either serve as storage or be abandoned. The single-story, front-gabled building is rectangular in plan and clad in stucco, with the exception of horizontal wood clapboards covering large opening in the south (main) elevation. The roof is sheathed with plywood, and appears to be collapsing. Fenestration is irregular, and the windows appear to be missing.

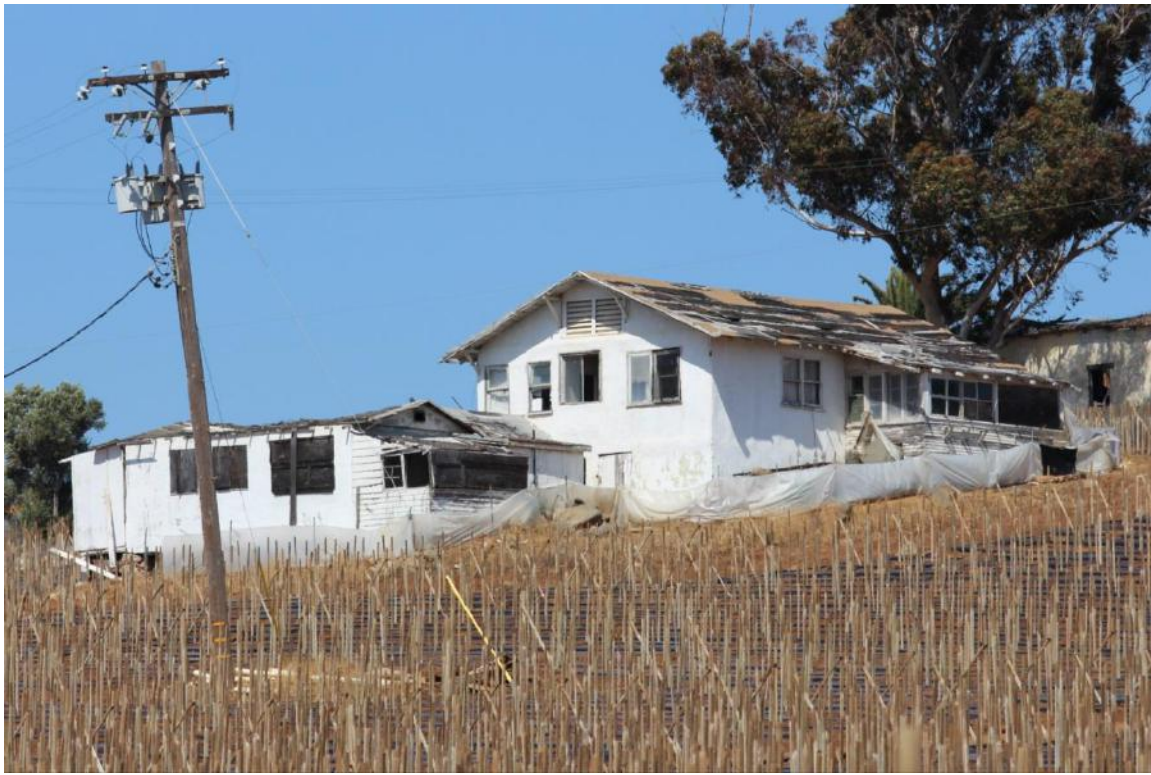
Figure 19 Large residence, view looking north-northeast. (IMG_8745)

Building 13 is a single-story, front-gabled residence designed in the Craftsman style. The building rests above a partial basement, and is clad in stucco and wood clapboards. The roof is sheathed with wood and then clad with deteriorating rolled asphalt roofing material. A shed-roofed addition just from half of the south elevation, while a series of side-gabled, front-gabled, and shed-roofed additions extend from the northern portion of the west elevation. Access is from the east (main) elevation, and fenestration is irregular. Observed window types include multiple-lite fixed windows, one-over-one double-hung windows, slider windows, fixed single-lite windows, and unidentifiable windows that are boarded over. A vertical-plank wood door grants access to the partial basement from the west elevation. The original Craftsman-style building was probably a single-family residence when first constructed, but now appears to either serve as storage space or is abandoned.

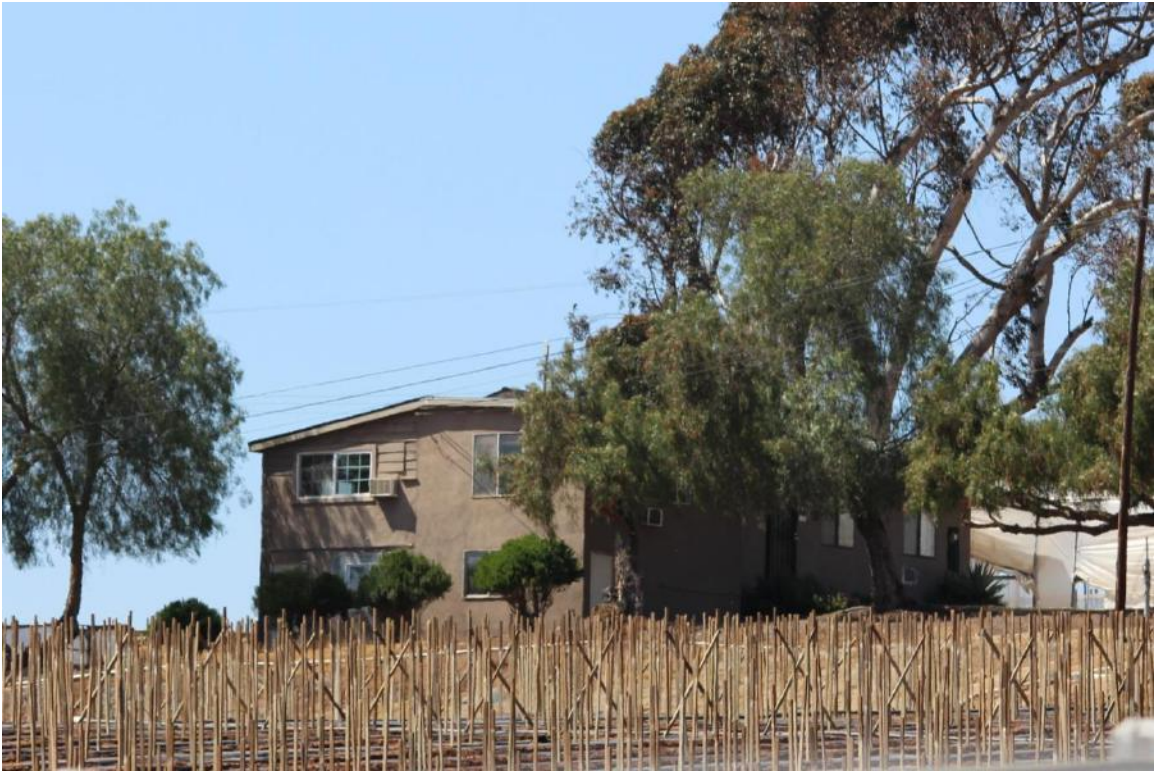
Figure 20 Office building, view looking northwest. (IMG_8736)

Building 14 is a single-story, side-gabled building with a couple of two-story additions to the south elevation. The building is rectangular in plan, and is predominately clad in stucco with some horizontal boards cladding the southwest quadrant. The building is accessed at several points by single doors, with a security door covering the main door on the east elevation. Fenestration is irregular, and windows types include sliding single-lite windows and sliding replacement windows with false grille work. The main building has a two-story, shed-roofed addition to the south, and a second two-story addition projects from the southern end of the east elevation of the first addition. The building likely served as a residence at one point, but now operates as offices for the agricultural company utilizing the surrounding land.

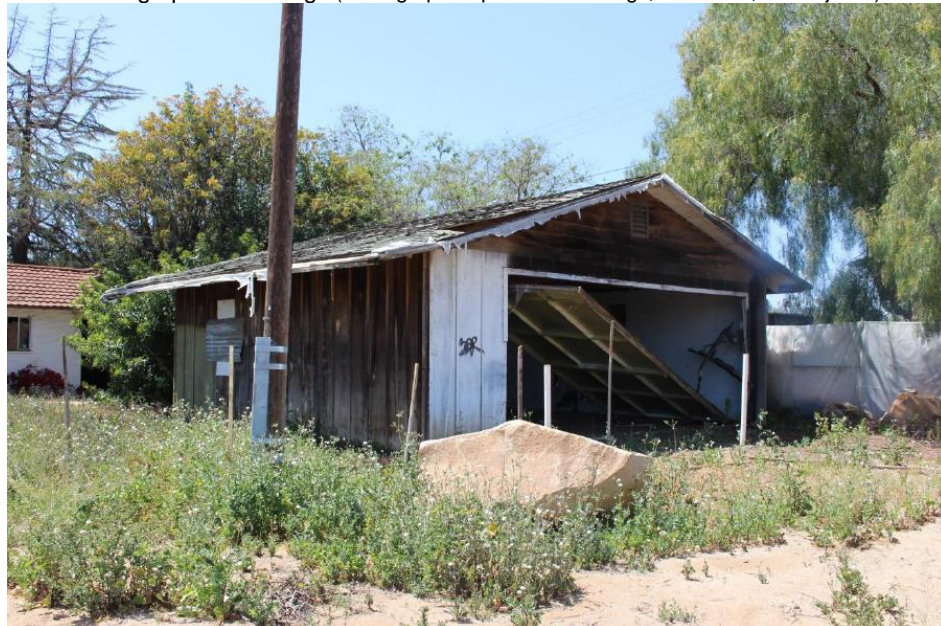
Building 1 is a front-gabled, two-car garage with board-and-batten exterior walls, and horizontal boards on the gable ends. The building rest on a concrete foundation. The roof is sheathed in plywood and covered in asphalt shingles. A detached up-and-over style wood garage door leans against the southern portion of the garage door opening on the east (main) elevation. Other fenestration includes two single windows, one each piercing the western portion of the north and south elevations, and a single doorway on the west elevation. The interior of the garage is finished, with a row of cabinets along the rear (west) wall.

P5b. Description of Photo: (view, date, accession #) Garage building, view looking northwest. (April 27, 2018; IMG 8496)

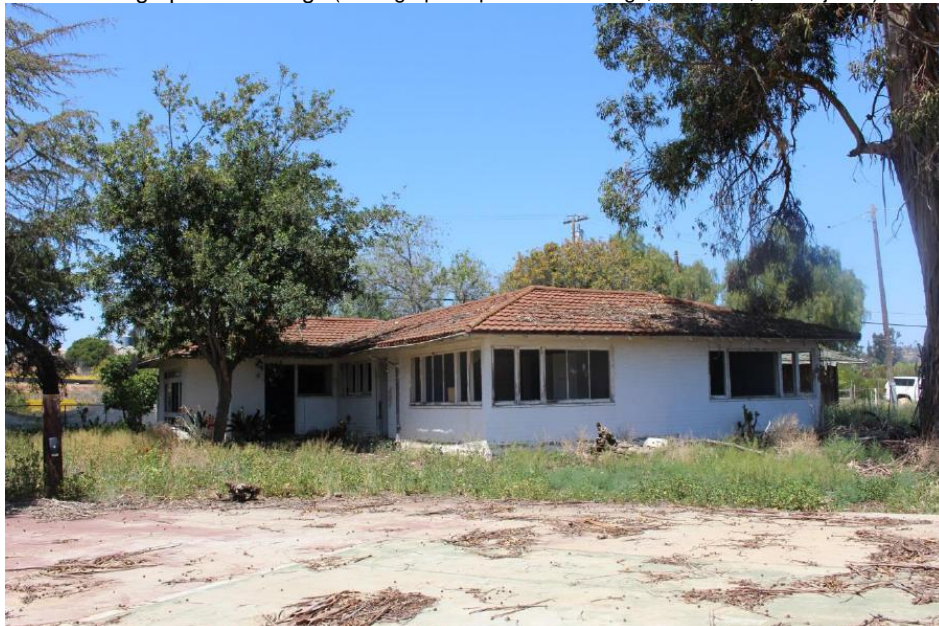
Building 2 is a single-story, brick single-family residence with a hipped roof clad in tile similar in shape to the Decra Classic lightweight steel tile. The building has a Z-shape in plan, and rests on a concrete foundation. Multiple single three-panel wood doors provide access on all but the north elevation. A French door provides access on the northern portion of the east elevation. Windows occur in ribbons that typically meet at the house corners. They are wood-framed and include single-lite casement windows, fixed single-lite windows, and fixed picture windows. The windows on the north elevation and north section of the west elevation are bordered on top and bottom with a string of narrow windows. A chimney juts upwards on the north elevation.

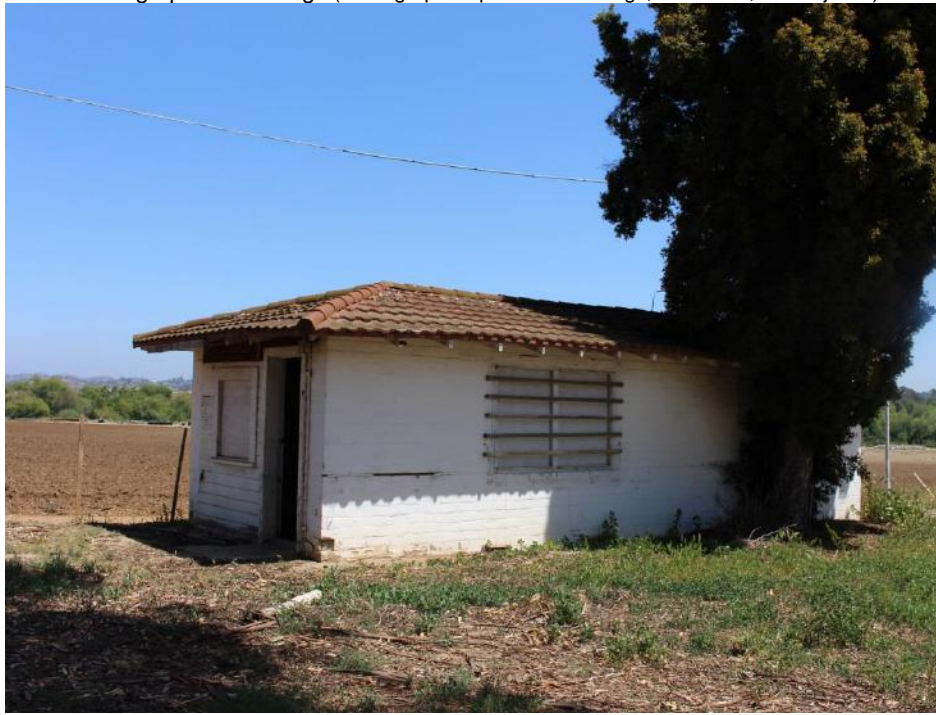
P5b. Description of Photo: (view, date, accession #) Small residence, view looking southeast. (April 27, 2018; IMG 8518)

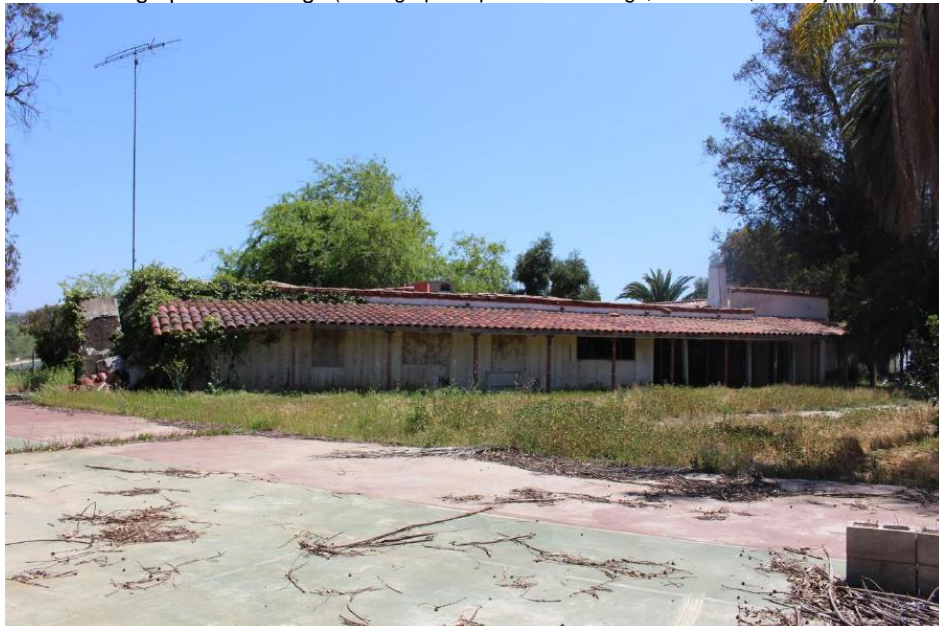
P5b. Description of Photo: (view, date, accession #) Large residence, view looking south - southwest. (April 27, 2018; IMG 8563)

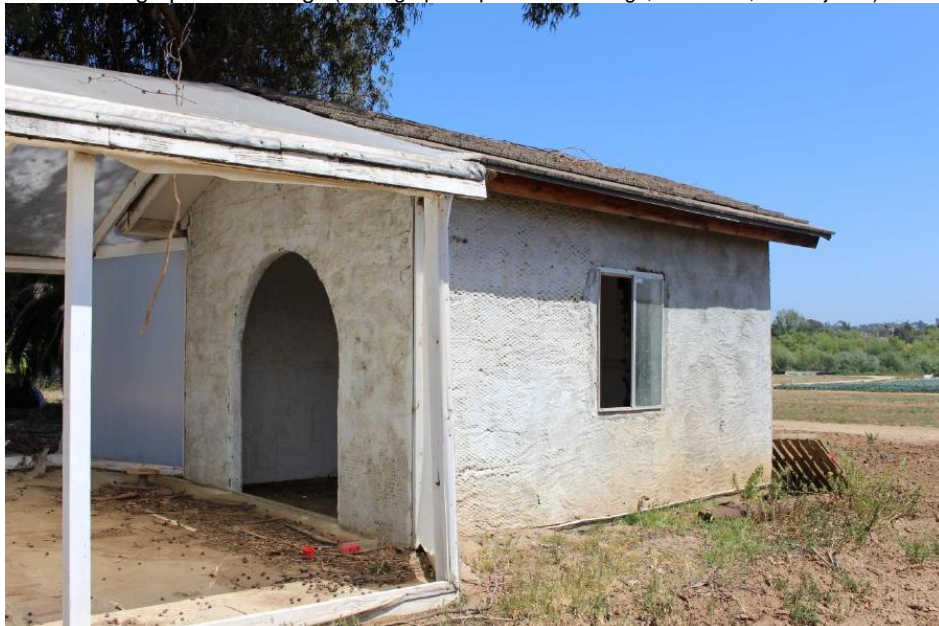
P5b. Description of Photo: (view, date, accession #) Miscellaneous building, view looking southeast. (April 27, 2018; IMG 8646)

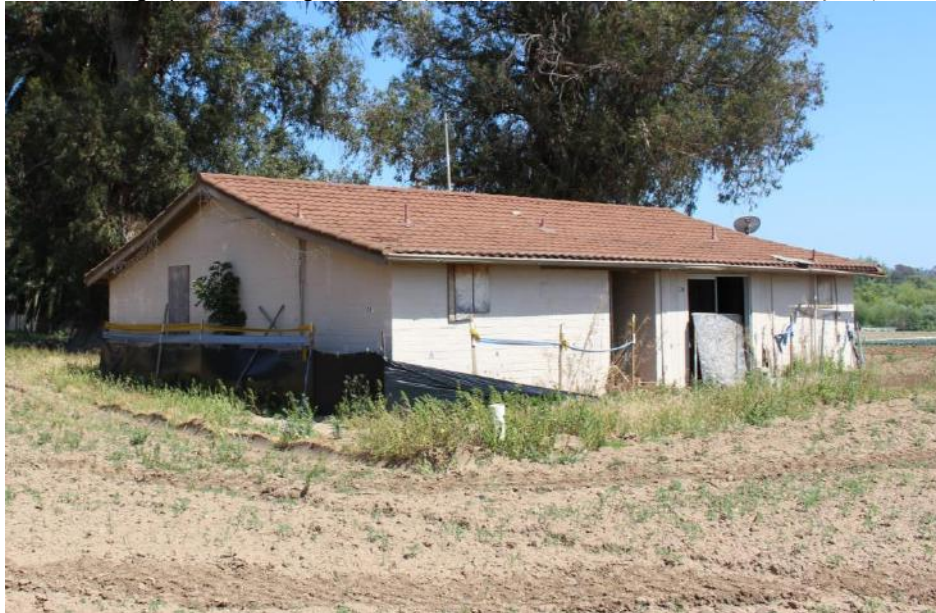
P5b. Description of Photo: (view, date, accession #) Residence, view looking southeast. (April 27, 2018; IMG 8651)

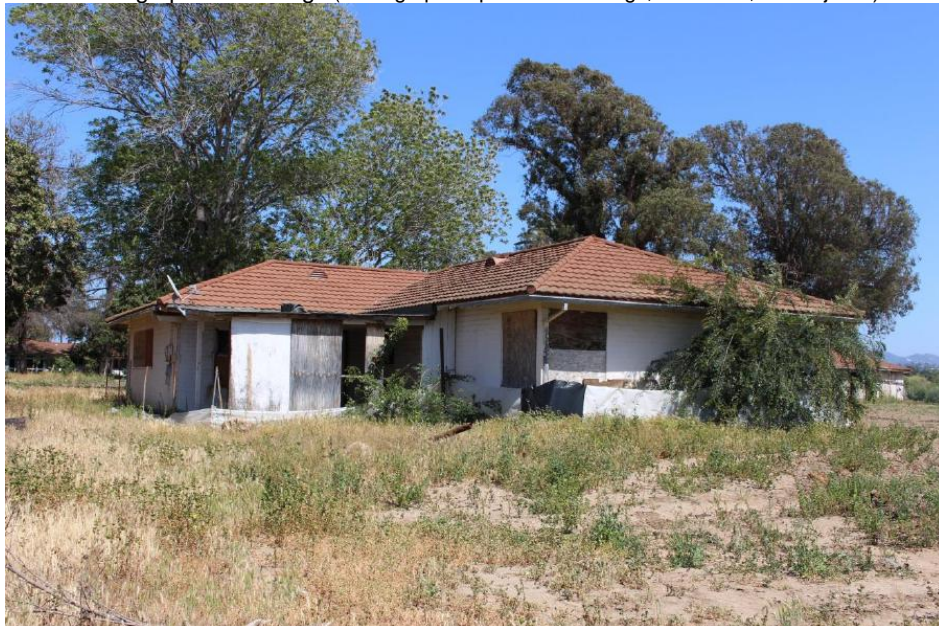
P5b. Description of Photo: (view, date, accession #) Residence, view looking southeast. (April 27, 2018; IMG 8665)

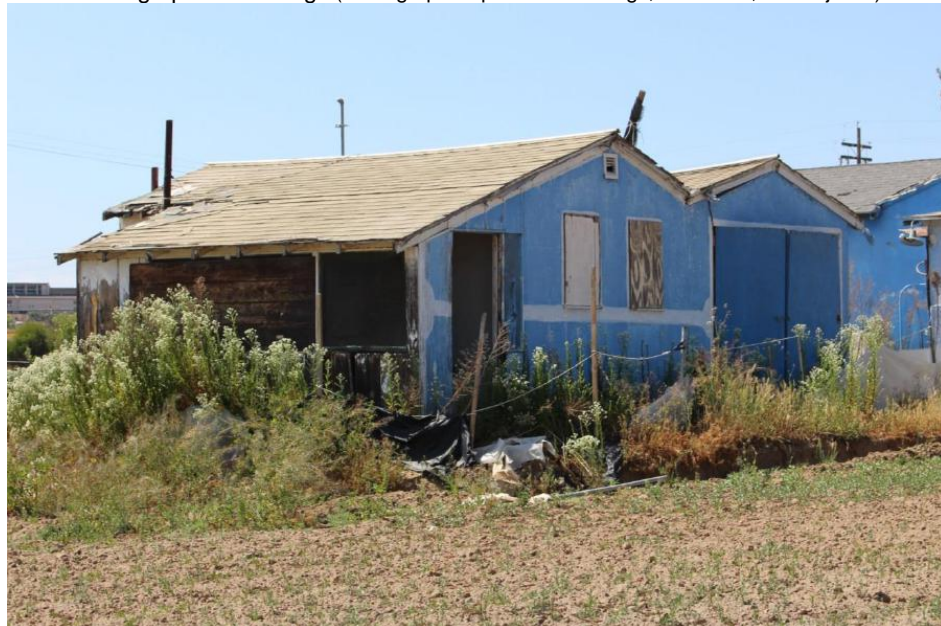
P5b. Description of Photo: (view, date, accession #) Residence, view looking northwest. (April 27, 2018; IMG 8695)
