Historical Resources Technical Report

HISTORICAL RESOURCES TECHNICAL REPORT FOR NORTH RIVER FARMS

5401 North River Road and 297 Wilshire Road,
Oceanside, California

JUNE 2018

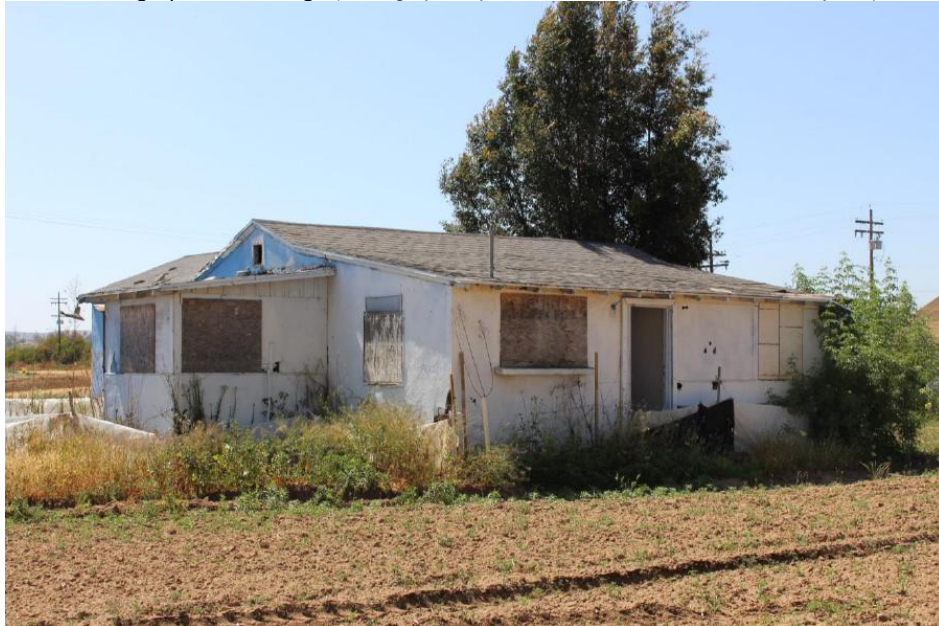
P5b. Description of Photo: (view, date, accession #) Residence, view looking northwest. (April 27, 2018; IMG 8702)

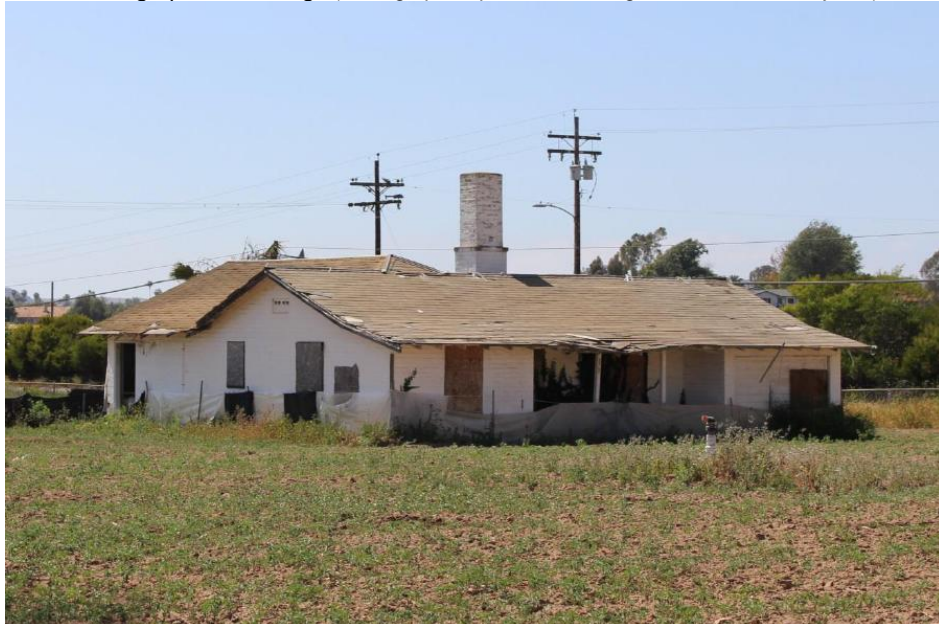
P5b. Description of Photo: (view, date, accession #) Residence, view looking northwest. (April 27, 2018; IMG 8709)

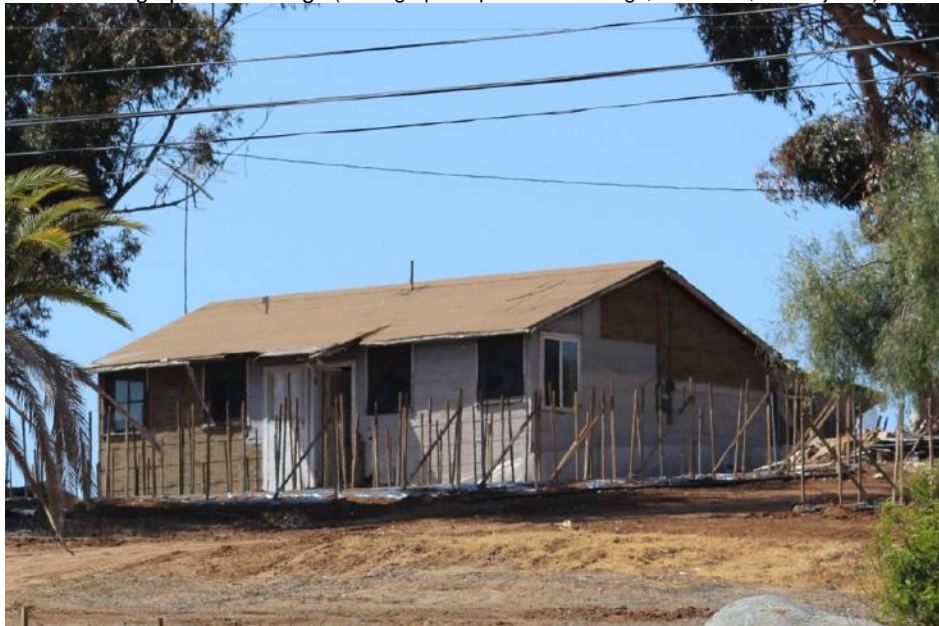
P5b. Description of Photo: (view, date, accession #) Residence, view looking northwest. (April 27, 2018; IMG 8740)

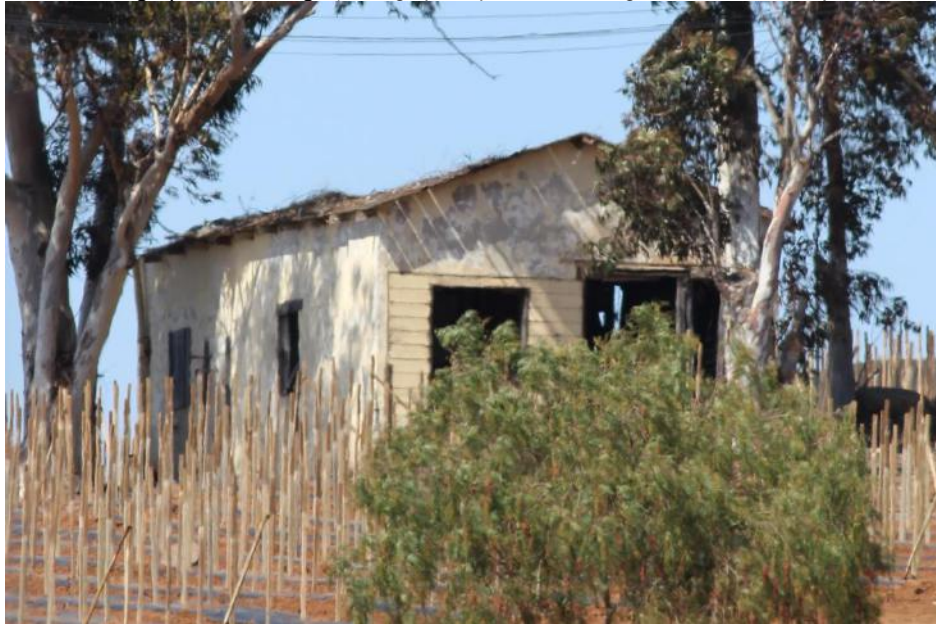
P5b. Description of Photo: (view, date, accession #) Residence, view looking northwest. (April 27, 2018; IMG 8746)

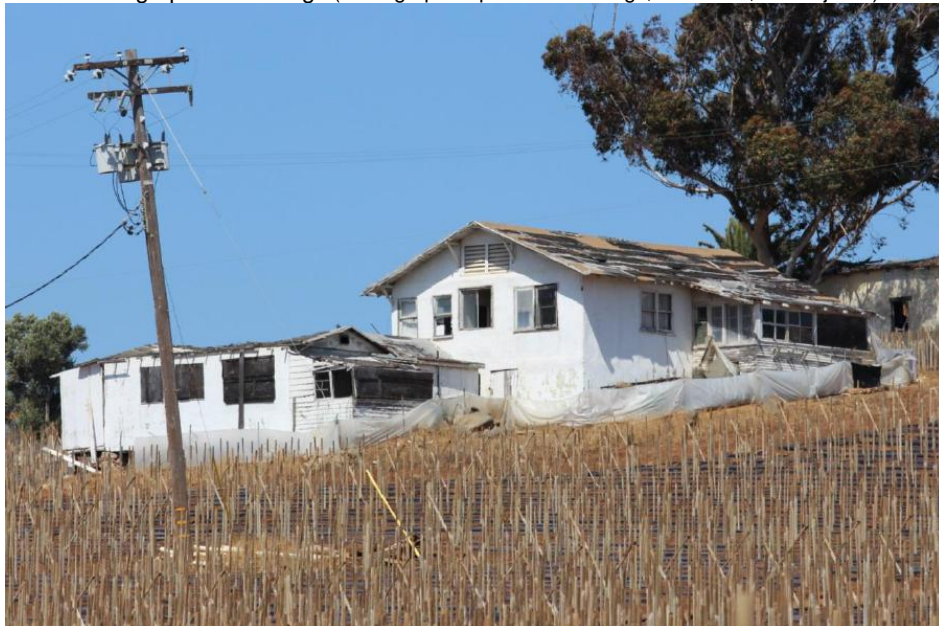
P5b. Description of Photo: (view, date, accession #) Residence, view looking north-northeast. (April 27, 2018; IMG 8745)

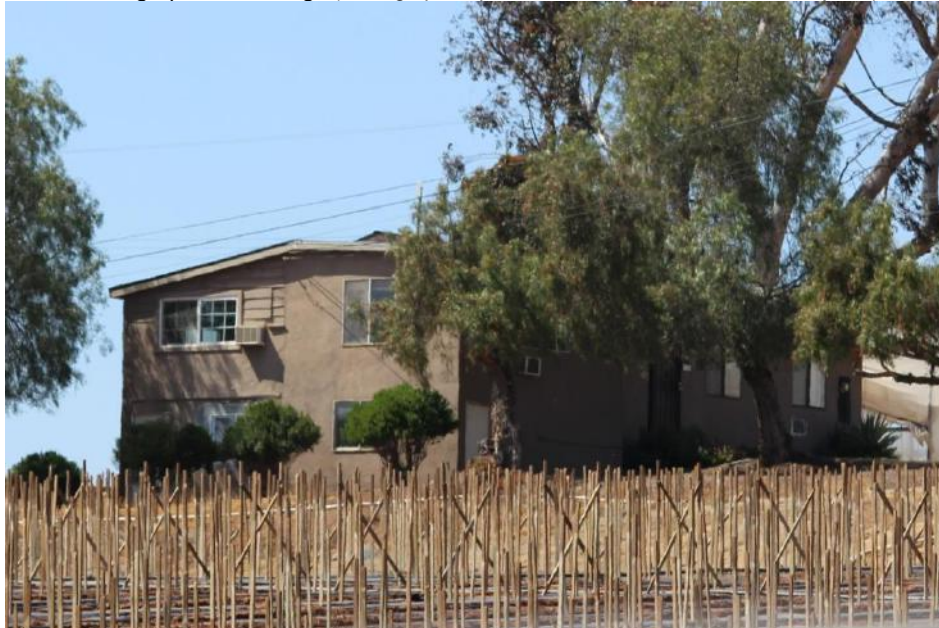
P5b. Description of Photo: (view, date, accession #) Office building, view looking northwest. (April 27, 2018; IMG 8736)
